ASSISTANCE EN ESCALE

SÉCURITÉ DES VOLS,
AGIR ENSEMBLE AU SOL

Structure awareness campaign for the Ground Handling community

Didier GENDRE
AIRBUS
Ground Operations & Ramp Safety

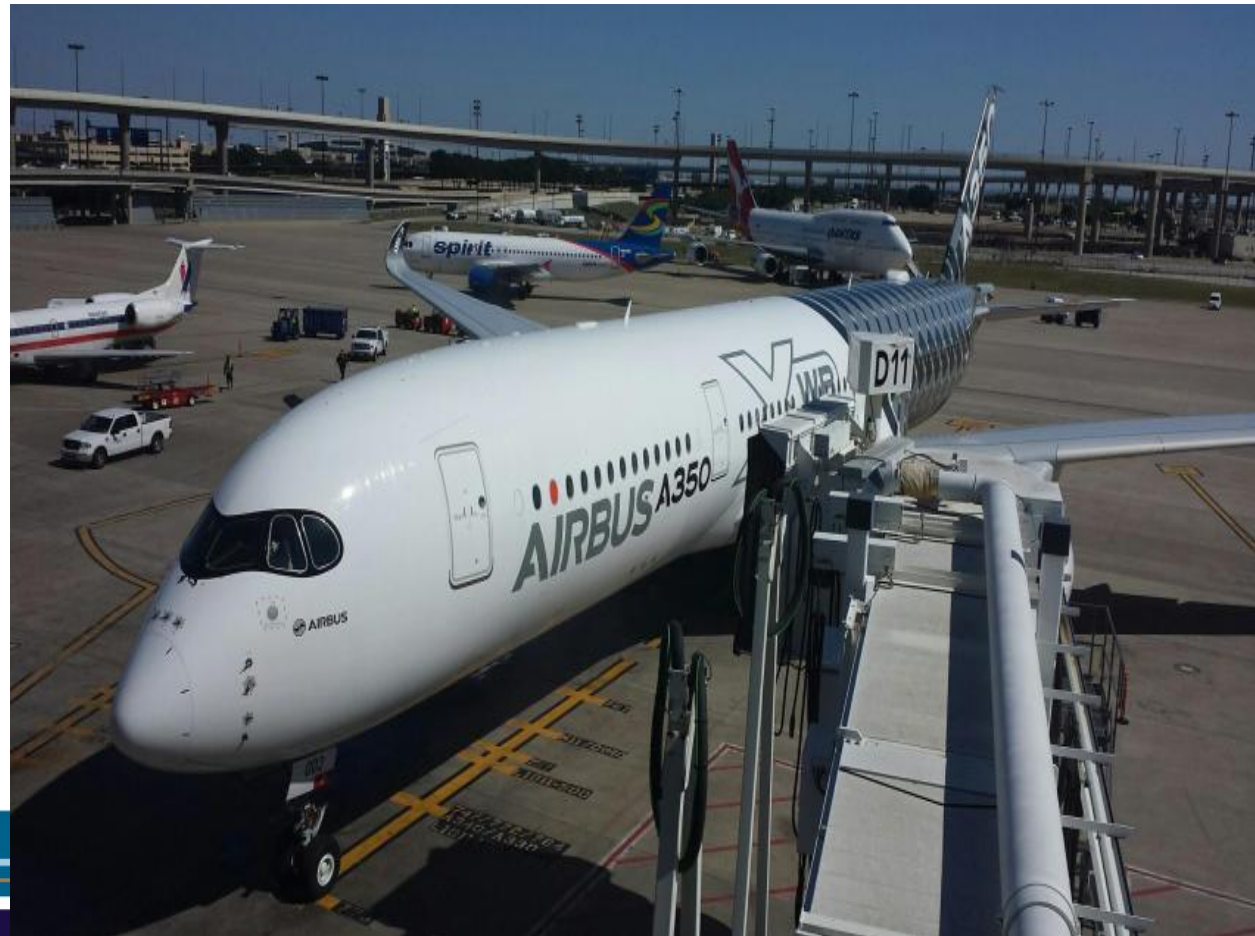
Titanium

- High load frames
- Door surroundings
- Landing gear
- Pylons

CFRP

- Wings
- Centre wing box and keel beam
- Tail cone (Section 19)
- Skin panels
- Frames, stringers and doublers
- Doors (Passenger & Cargo)

With the fuselage in Carbon Fiber Reinforced Plastic (CFRP), the ground handler working area has changed !

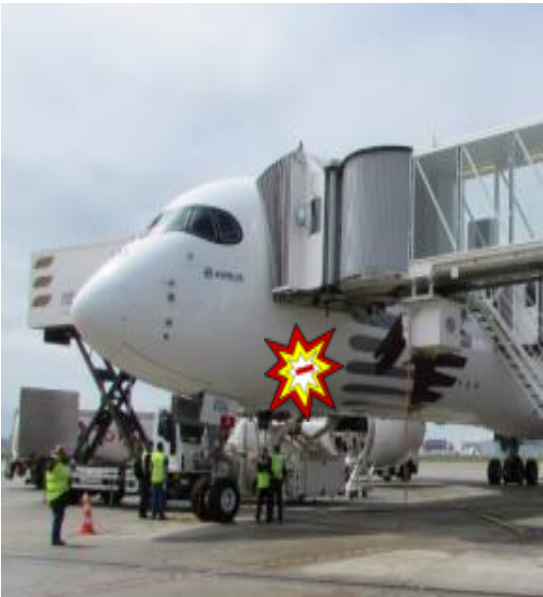
IMPACT WITH VISUAL INDICATION OF DAMAGE

GSE IMPACT EVIDENCE

DELAMINATION AND CRACKS BETWEEN PLIES

IMPACT WITHOUT EXTERNAL INDICATION, BUT WITH INTERNAL DAMAGE

INTERNAL STRUCTURE BROKEN

GSE IMPACT AREA, WITHOUT EVIDENCE

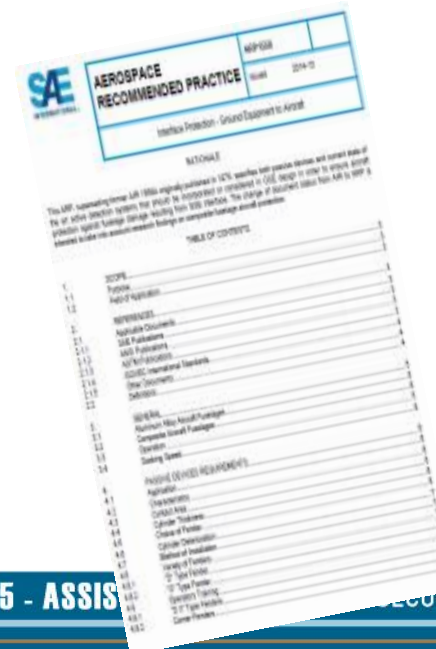
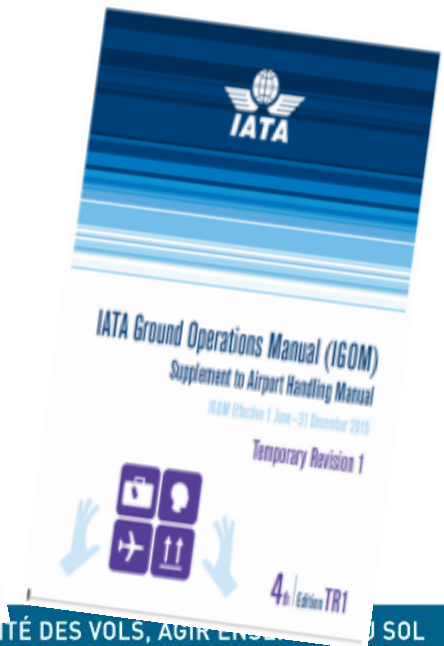
- Our ground handling training does not cover procedures as this doesn't fall under the manufacturer's responsibility
- Nevertheless, our recommendation is to make use of international standards and best practices

- SAE recommended practices
- IATA Ground Operations Manual (IGOM)

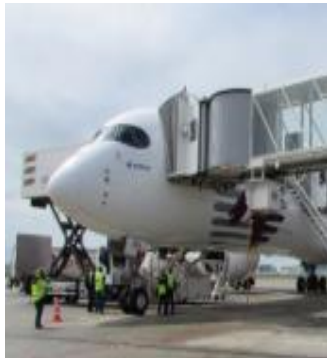
Airbus is supporting actively the GHI, IATA, SAE & ISO activities to reduce ramp damage

- Improve procedures – low speed near aircraft,
- Improve GSE standards – anti collision, speed limits, bumpers, impact detection and data logging
- Improve GSE maintenance

Such enhancements will be specifically beneficial for A350

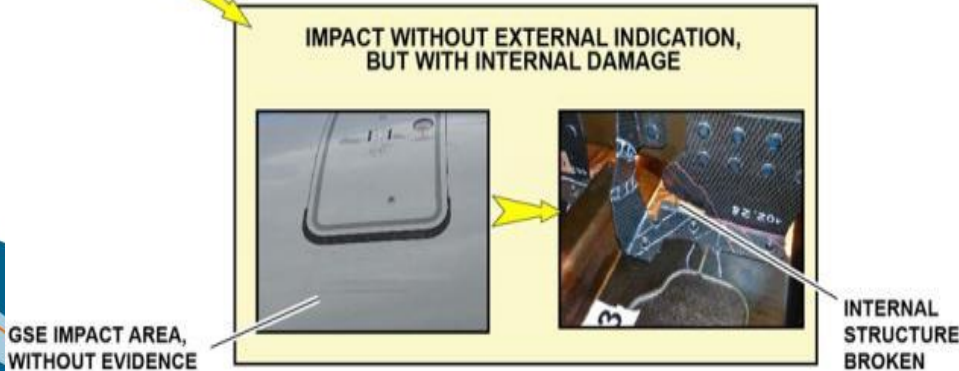
AIRLINE
GROUND INCIDENT/ACCIDENT DAMAGE REPORT

It is recommended to make use of defined damage report templates including a maximum of information on the event

- Aircraft impact location
- Type of GSE
- Part of GSE impacting the fuselage
- Type of GSE interface protection (soft or hard bumper)
- Any visible damage: scratch, dents or marks...
- Did aircraft shake violently
- Aircraft skin deformation observed
- Any noise heard?
- Speed of GSE at time of impact
